Department of Environmental Quality

RE: Drilling Notification No. 366DN, WildHorse Energy, Inc., October Inspection

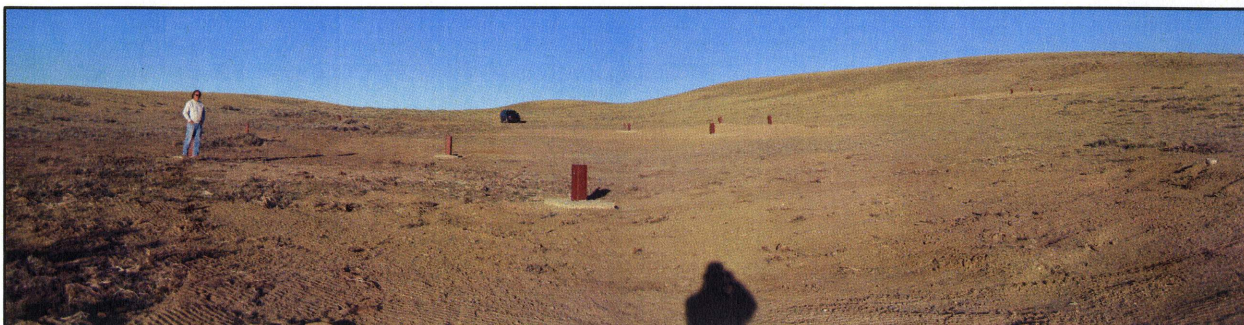
Inspection of the site indicated that areas around the following wells had been graded and seeded: (1) Well Nest 1 (4 wells), (2) Well Nest 2 (2 wells), (3) Well Nest 3 (4 wells), (4) Well Nest 4 (4 wells), WHED-5, WHED-6, WHED-7, WHEU-8, WHEU-9, and WHEB-11. All wells were found to have locking caps, with locks in place, and concrete pedestals that contained the Well I.D. number. In addition to the above work, the road located along the west side of the storage trailer had been reclaimed. The attached photos document the above work. One potential problem was noted during the inspection in Well Nest 1. It is understood during the completion of the various wells that circulation became a problem and in some instances holes were abandoned and redrilled. It appears that there has been settling in one of these abandoned holes to the point where there is a 10-inch void (approximate) at the surface underlain by a minimum of 15 inches of extremely soft material. While I am not asking for immediate remediation, this location should be inspected next Spring and corrective action implemented as required.

Photo (above) looks NNW across the Well Fields 1 – 4. Photo below looks NW at the reclamation at WHED-6, which is typical of the reclamation observed at each well site.

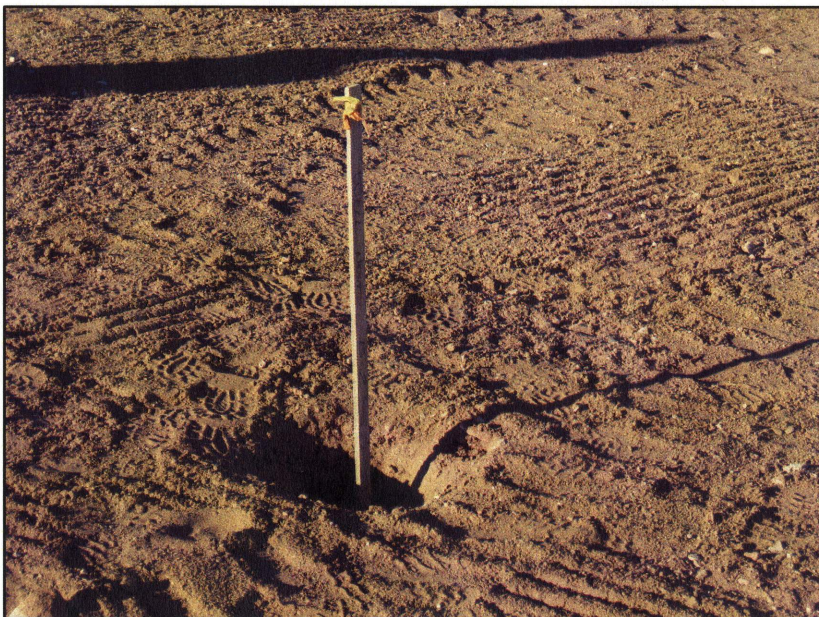
Photo below shows the slightly subsided abandon hole in Well Nest 1. The lathe was placed in the hole to provide some indication of scale.
